WARREN H. OHL DAM

INVENTORY NUMBER NDS 394

PHASE I INSPECTION REPORT

NATIONAL DAM INSPECTION PROGRAM

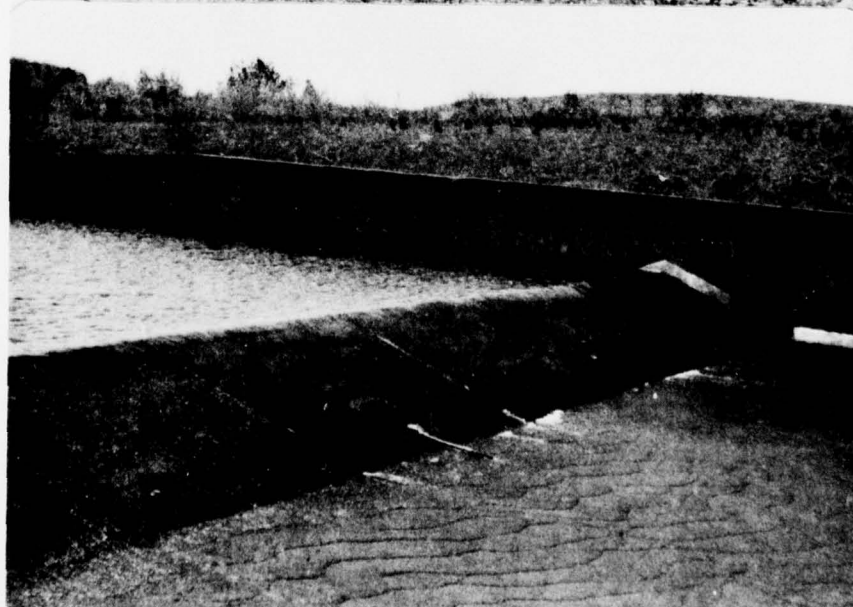
The spillway crest and walls are in good condition, except for a few cracks. The spillway slab shows slight deterioration. Cracking is caused by the excessive length of individual monoliths.

Spillway
Weir

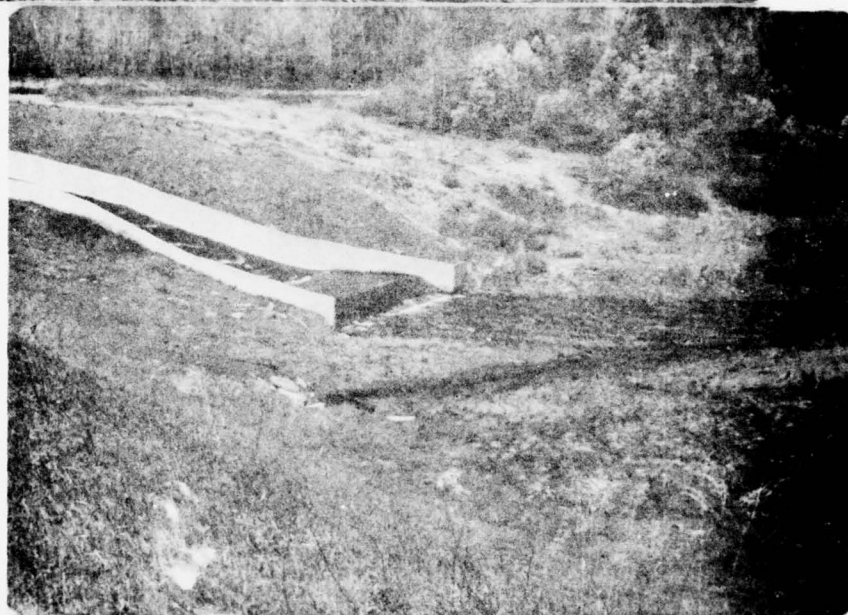
Downstream
Toe

Entire toe of embankment slope wet and soggy from leakage.

1. Owner should control the seepage existing on the embankment slope and along the toe.
2. Owner should investigate the cause of and provide for the control of standing surface water between the embankment and the spillway.
3. Backfill all woodchuck holes.
4. Owner should monitor and record seepage quantities. If the flow increases with time, implement remedial measures at once.

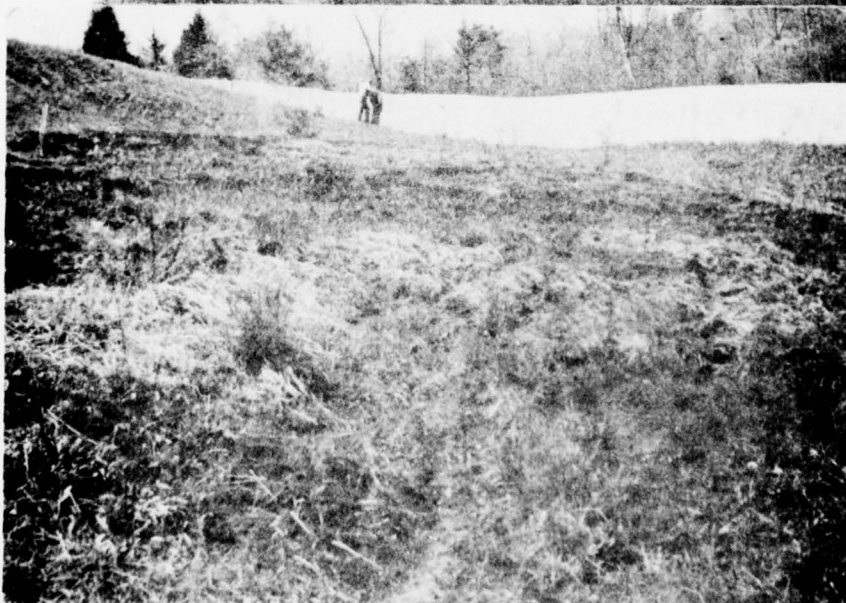
The dam embankment is maintained in fair condition. There is evidence of seepage on the slope and the toe was wet and soft in some areas. A few places on the embankment indicated mole activity. Between the embankment and the spillway is a large wet area. (See sketch in Appendix A). There was no evidence of cracking or visually detectable settlement in the embankment. Some sloughage has occurred close to the conduit. The riprap on the upstream slope and the dam crest road is in excellent condition. The drain near the downstream end of the spillway wall carried a considerable amount of water (Appendix D, Plate IV, top photograph).

- a. Seepage between the right spillway wall and the dam embankment and in the area of the conduit outlet. Seepage could originate from the fractured rock strata below and adjacent to the dam which was not grouted or from the embankment. Additional studies should investigate and identify the source.
- b. There are no weepholes in the spillway walls. The amount of leakage water could cause instability of the walls if the drain would clog up.

Seepage close
To Spillway

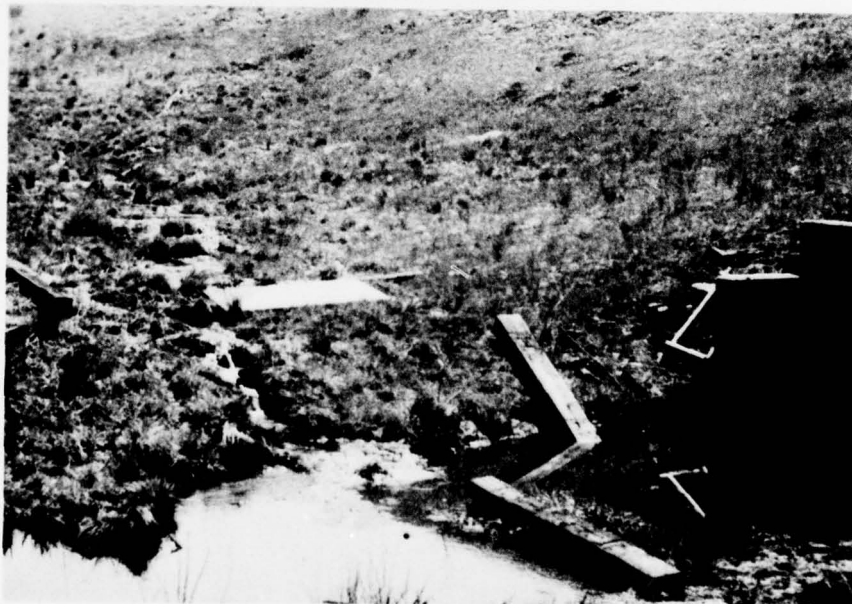
Conduit
Conduit Outlet
and Right
Abutment Seepage
